ENVIRONMENTAL NEWS

H A M I L T O N A R M Y A I R F I E L D

COASTAL SALT MARSH PROJECTS COMPLETED

Spring 2005

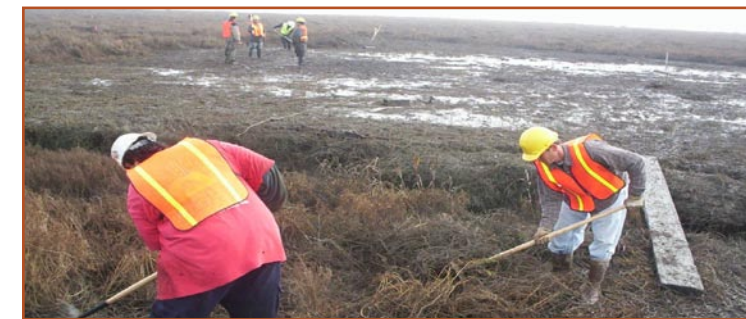
Pickleweed Removal

Clean-up in the Coastal Salt Marsh began on December 14, 2004 with the hand-removal of pickleweed. Pickleweed is dense vegetation that covers most of the Coastal Salt Marsh

and provides food and shelter to several marsh species. The pickleweed was hand-cleared to reduce the chances of harm to the endangered mice or birds in the vicinity. After the pickle-

weed was cleared, a barrier fence was installed to prevent the animals from entering the work area where heavy machinery was moving around.

Excavated sites were backfilled with clean soil. Re-growth of pickleweed is expected at these sites.

The Army will monitor the pickleweed re-growth and take necessary actions to ensure that the habitat grows back.

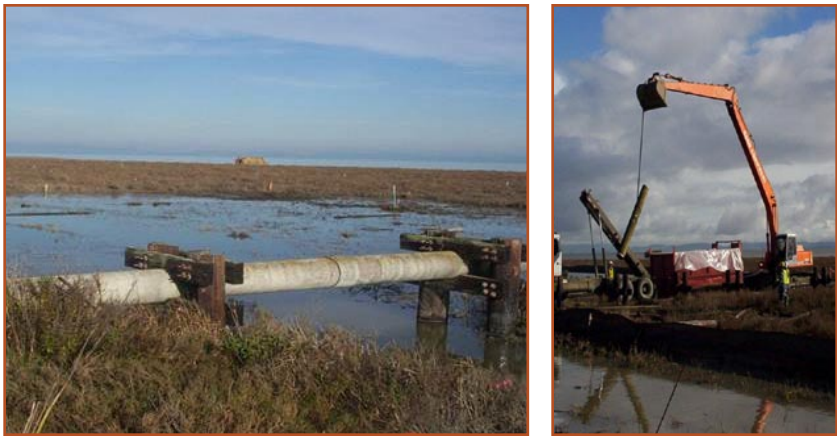
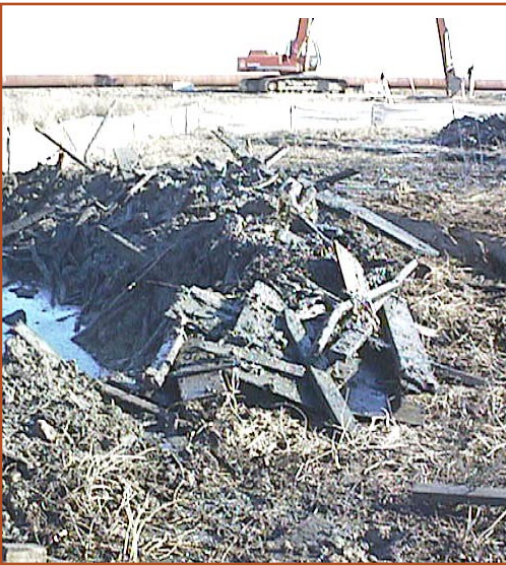
Former Sewage Treatment Plant Pipeline & Outfall

It took approximately three hours for Army contractors to remove 450 feet of pipeline that crossed the Coastal Salt Marsh. The pipe originated at the Former Sewage Treatment Plant and was used to carry treated wastewater to the bay. The location where the pipeline emptied into the bay, referred to as the “outfall,” was excavated for soil containing metals and pesticides with levels above the cleanup goals. The pipeline itself was removed since it was not flushed when it was retired and could be a potential source of contamination.

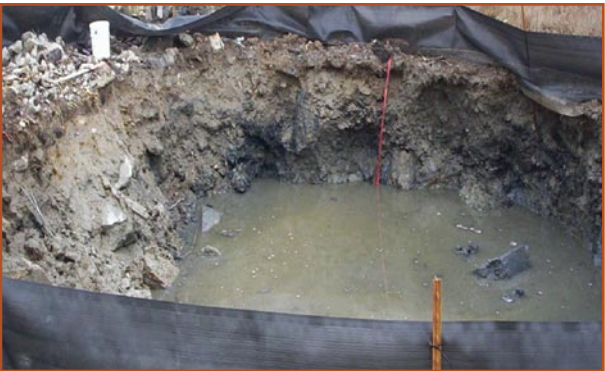
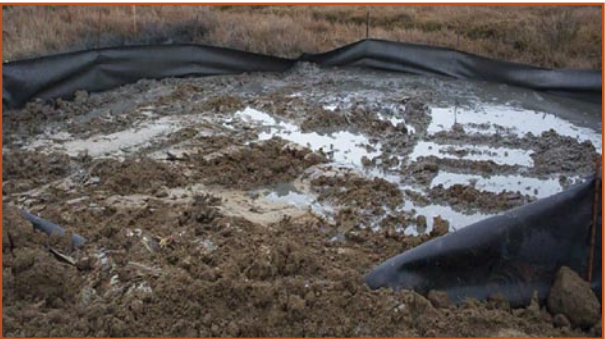
EAST LEVEE CONSTRUCTION DEBRIS DISPOSAL AREA (ELCDDA) & BURN PIT

The ELCDDA and burn pit areas were in use circa 1961 as a final destination for construction debris. In January 2005, the Army excavated the construction debris and soil containing metals above the cleanup goals.

In order to allow heavy equipment access to the ELCDDA and Burn Pit, a road was constructed next to the wetland project’s dredge pipeline. The pipeline was built to transport dredge material for wetland construction. The road will remain in place for pipeline access during the wetland restoration project.

Once the debris was removed from the ELCDDA, the area was graded down to an elevation suitable for pickleweed growth, thereby potentially gaining an acre of endangered species habitat.

The road was constructed next to the pipeline to allow heavy excavation equipment access to the site. The road will remain in place for the duration of the wetland restoration project to maintain the pipeline.

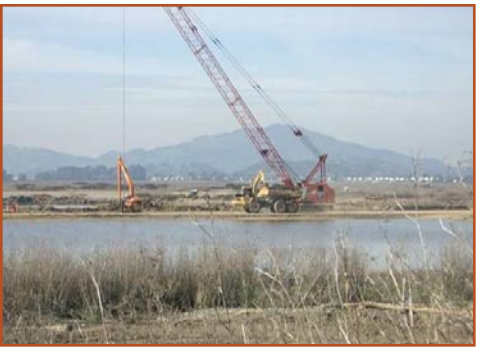
SCRAPING FOR CLEAN BACKFILL

The clean soil that was used for backfill in the Coastal Salt Marsh was obtained from a site about 1000 ft inboard of the levee. This location coincides with the path of the future wetland’s main water channel.

The soil at this location was used because it had the cleanliness and grain size to fit the surrounding soil in the marsh.

Pictured here, a crane and an excavator were used to load soil on to the dump-truck. The dump-truck then carried the soil to the excavation sites.

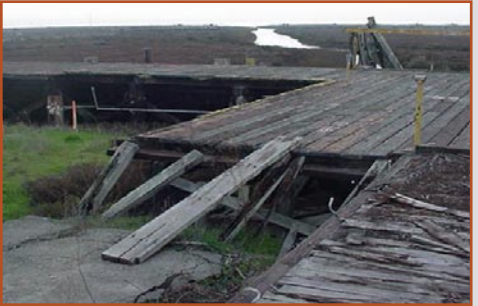
BOAT DOCK

The Boat dock /launch was built in the 1930s for water rescue emergencies such as an aircraft crash in the bay. Boat maintenance activities at the dock are the probable source of metals in the mud beneath the dock. A portion of the structure was dismantled on January 10, 2005 to access the mud beneath. Excavation occurred on the 15th – 17th. The area was backfilled on January 27th and 28th.

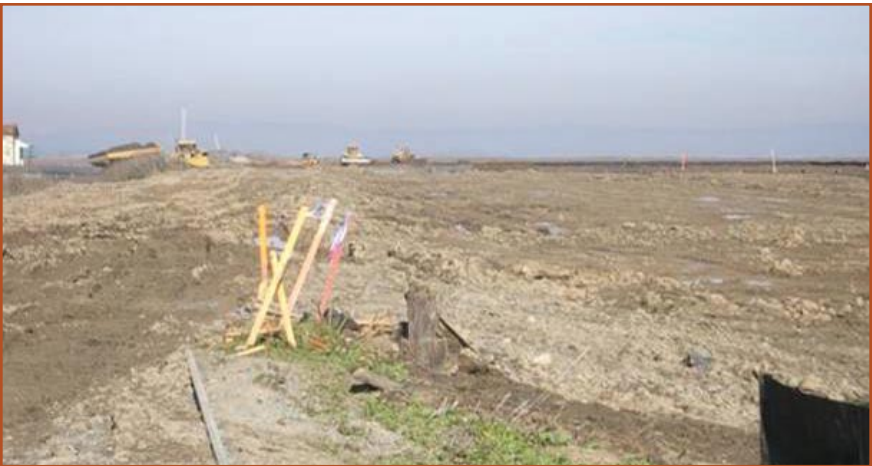
High Marsh Backfilled

The High Marsh Plain is a 2-acre area within the Coastal Salt Marsh that had “hotspots” of contamination above action goals. The Army excavated soil containing metals, petroleum, pesticides, and PCBs beginning December 29, 2004. The excavation was backfilled and graded to recreate the previously existing drainage pattern for tidal and rainwaters. Backfill was completed on January 14, 2005.

The High Marsh Grid is a 3-acre area north of the High Marsh Plain with similar characteristics. The Army excavated soil containing metals, petroleum, pesticides, and PCBs with levels above the cleanup goals. The excavation began on January 10, 2005. Backfilling began January 25th and the site was graded to recreate the previously existing drainage pattern for tidal and rainwaters.

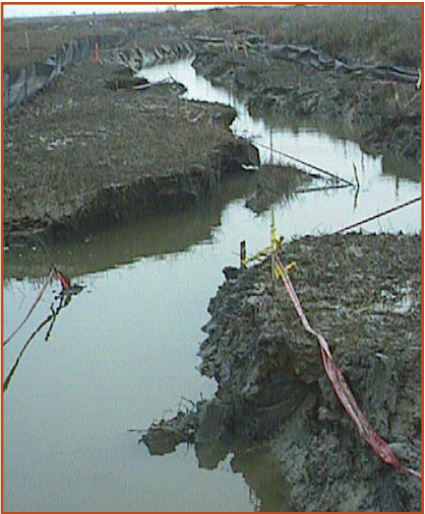
Historic Outfall Drainage Ditch

The Historic ODD runs from the ELCDDA (see previous page) toward the boat dock. The channel has not been used to carry storm-water since the 1950’s. The Army excavated the channel and removed soil containing metals and pesticides with levels above the cleanup goals.

Excavation began and was completed in one day on January 18, 2005.
